## MEDIUM VOLTAGE CABLE SPIKING TOOL

# FUNCTIONAL TEST WITH FAULT CURRENT

K-352093-001- R00

SPIKE Tool INC.  
2301-25 Broadway Avenue  
Toronto, Ontario,  
Canada, M4P 1T7

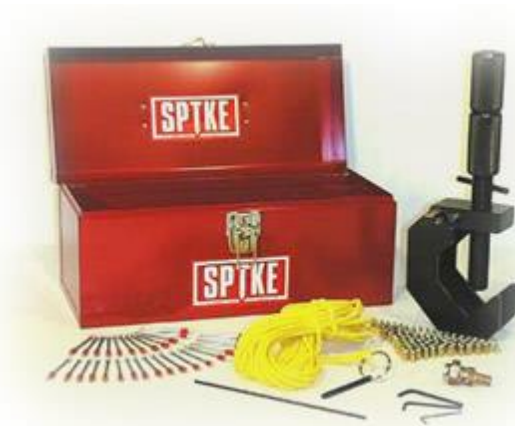
**Figure 5-1: View of cable SPIKE Tool kit (from website).**

A view of the SPIKE tool and accessories is shown in Figure 5-1.

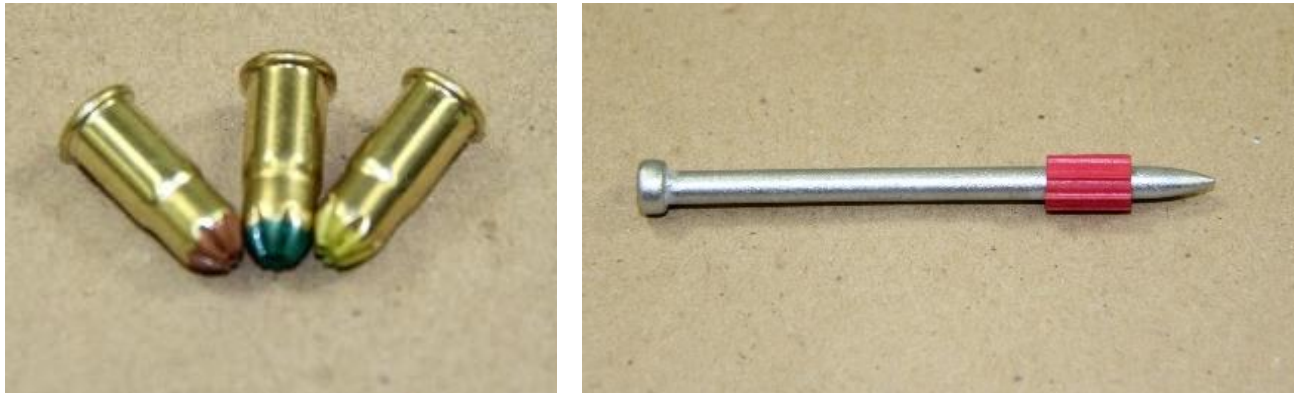
**Figure 5-2: Cartridge and hardened nail supplied with SPIKE.**

Test samples were received for testing at Kinectrics on June 15, 2018 in new condition. Based on the product literature, the tool can accommodate a cable up to approximately 90 mm (3½") and is supplied with three different cartridge power loads (colour coded with brown, green and yellow). A chart is provided for the user to select the correct cartridge for the size of cable being spiked. The tool is also provided with hardened 50 mm (2") nails. Photographs of the cartridge and nail are shown in Figure 5-2.

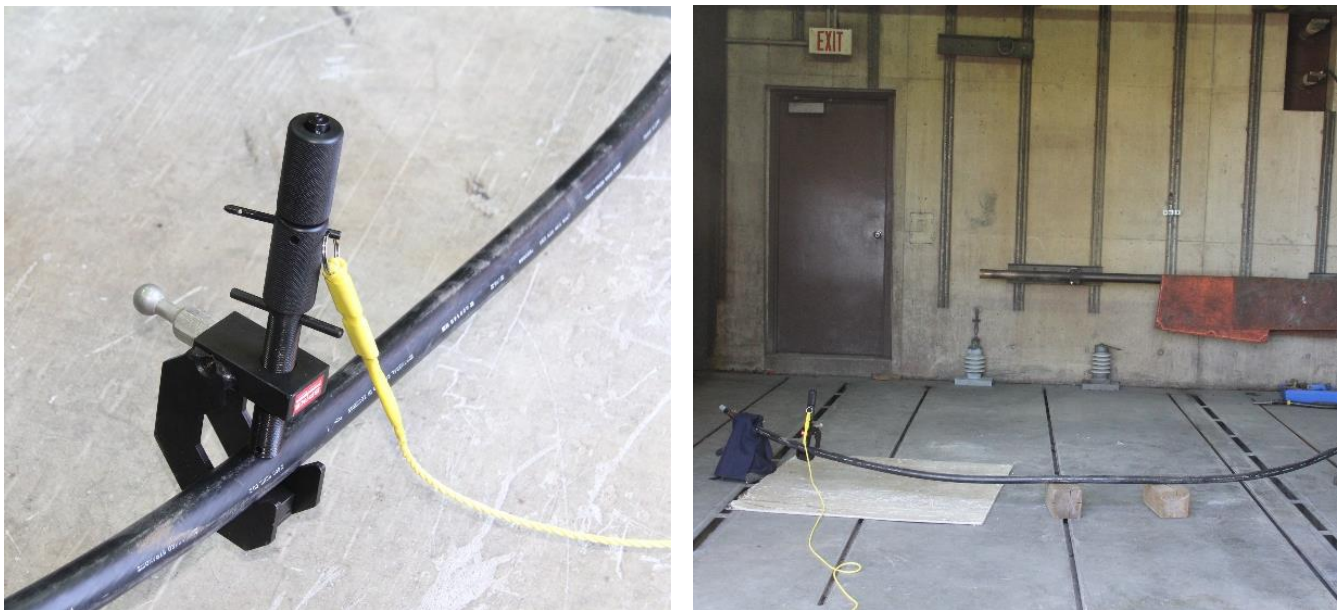
**Figure 6-1: Setup of ungrounded SPIKE tool.**

1- Ungrounded having the fault current return through the concentric neutral wires. Setup as shown in Figure 6-1.

Test 3234 was performed with the tool installed on a 15 kV, 500 kcmil copper cable with the concentric neutral wires grounded, the SPIKE tool remained ungrounded, see Figure 6-1 for the installation. In this case, the tool pierces the cable and initiates the fault but does not carry any of the fault current. All current returns through the cable concentric neutral wires or shield.

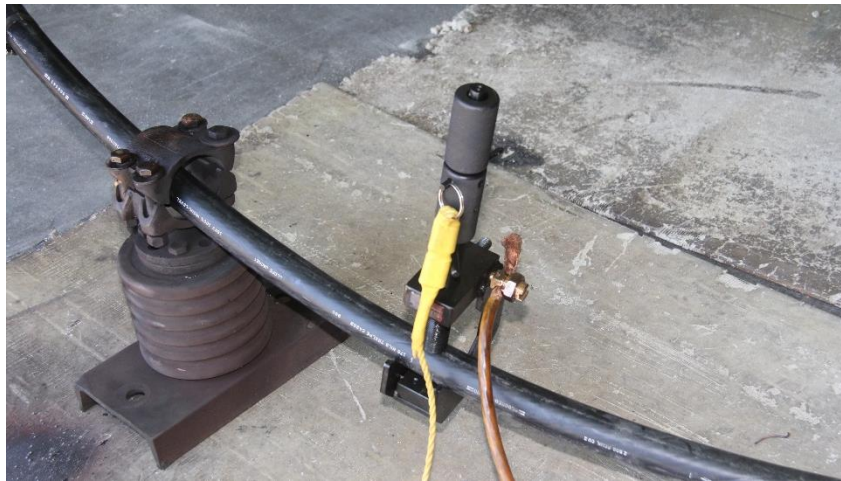
**Figure 6-2: Setup of grounded SPIKE tool using split-bolt.**

2- Bonded with additional ground cable connected to either the split bolt or the 25 mm ball stud with a grounding clamp. For these tests, the concentric neutral wires on the test cable were isolated allowing all the current to flow through the tool. In Figure 6-2, the grounding of the tool was made with 1/0 AWG copper flex conductor. This is the largest conductor that can be accommodated in the split-bolt mechanical lug supplied with the tool as currently sold. The split-bolt screws into the side of the SPIKE tool. Testing with the 1/0 AWG conductor with the split-bolt was limited to 14 kA.

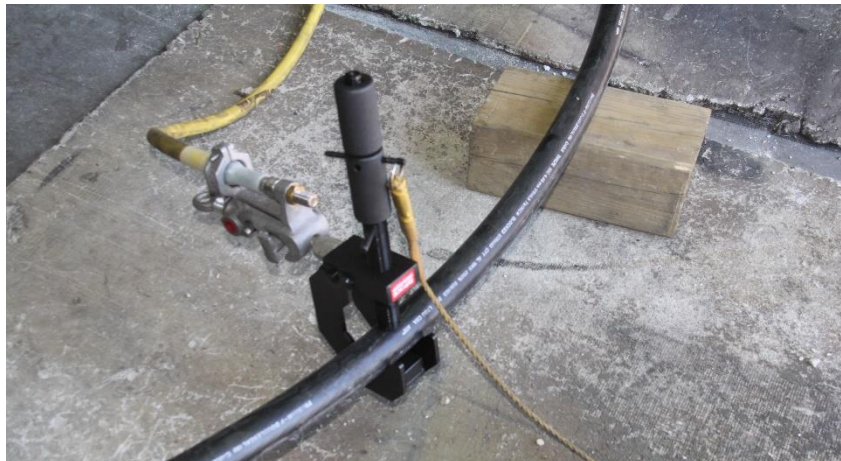
**Figure 6-3: Setup of grounded SPIKE tool using 25 mm ball-stud.**

The setup shown in Figure 6-3 used the new design which incorporates a 25 mm copper ball-stud for attaching a ground clamp. A number of different commercially available clamps are designed for use on a ball stud.

To adapt to modern clamps and provide a more secure ground connection, an alternate ground method was evaluated using a 25 mm ball stud threaded into the back of the tool. The ball stud is made of tinned copper and has a ½”-13 NC thread. The ball stud installed on the SPIKE tool was Maclean Power HC-30029-1 which is rated up to 43 kA (ASTM F855) which is much higher than the expected range on this tool. The SPIKE tool with the ball stud installed is shown in Figures 6-1 and 6-3 with a ground cable attached.

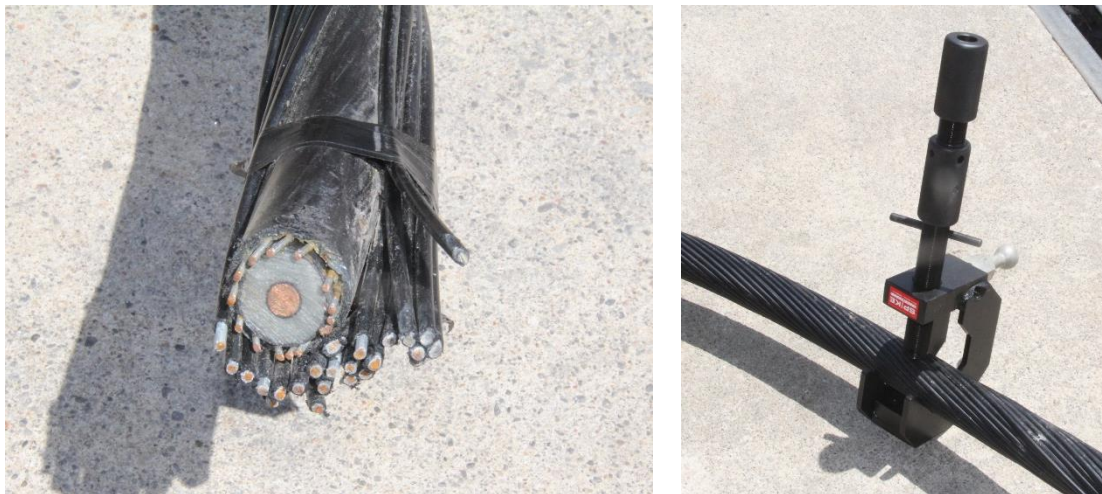
**Figure 8-1: SPIKE installed on steel armoured cable.**

With steel armoured cable, the tool barrel was positioned to be aligned with the nail over an armor shield wire as worst case scenario. In the tests performed, the nail always veered to one side or the other and fully pierced the cable and main conductor. See Figures 8-1 and 8-2.

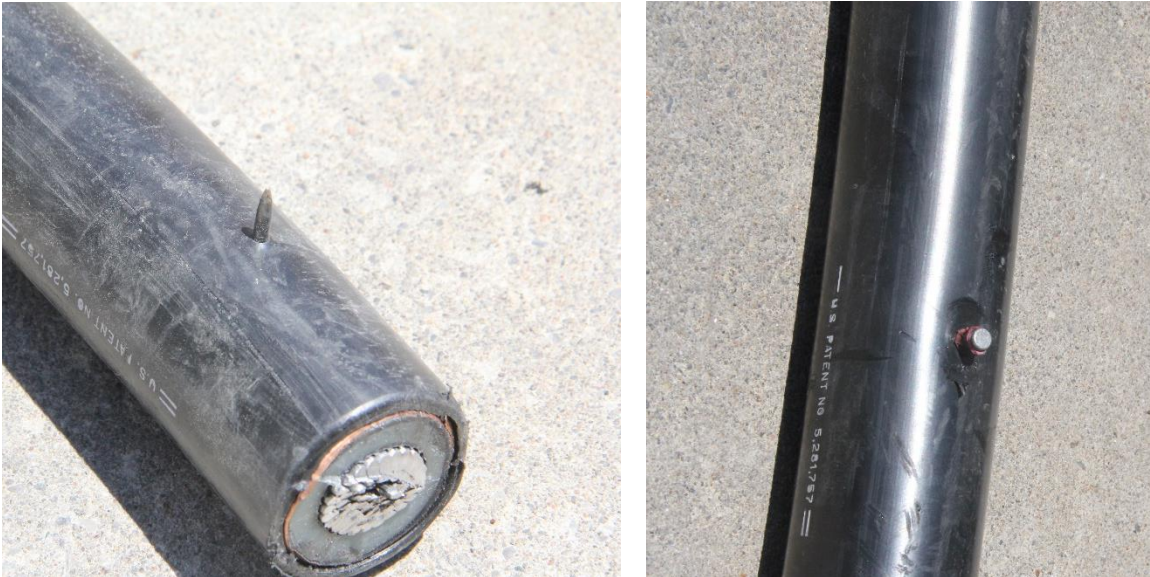
**Figure 8-4: Nail punctured through on 28 kV, 1000 kcmil aluminum conductor**

This cable was the largest diameter cable that was available for evaluation. Using the green cartridge as indicated in the instruction manual, the nail fully penetrated the cable and projected out the other side and hit the striker plate. See Figure 8-4.

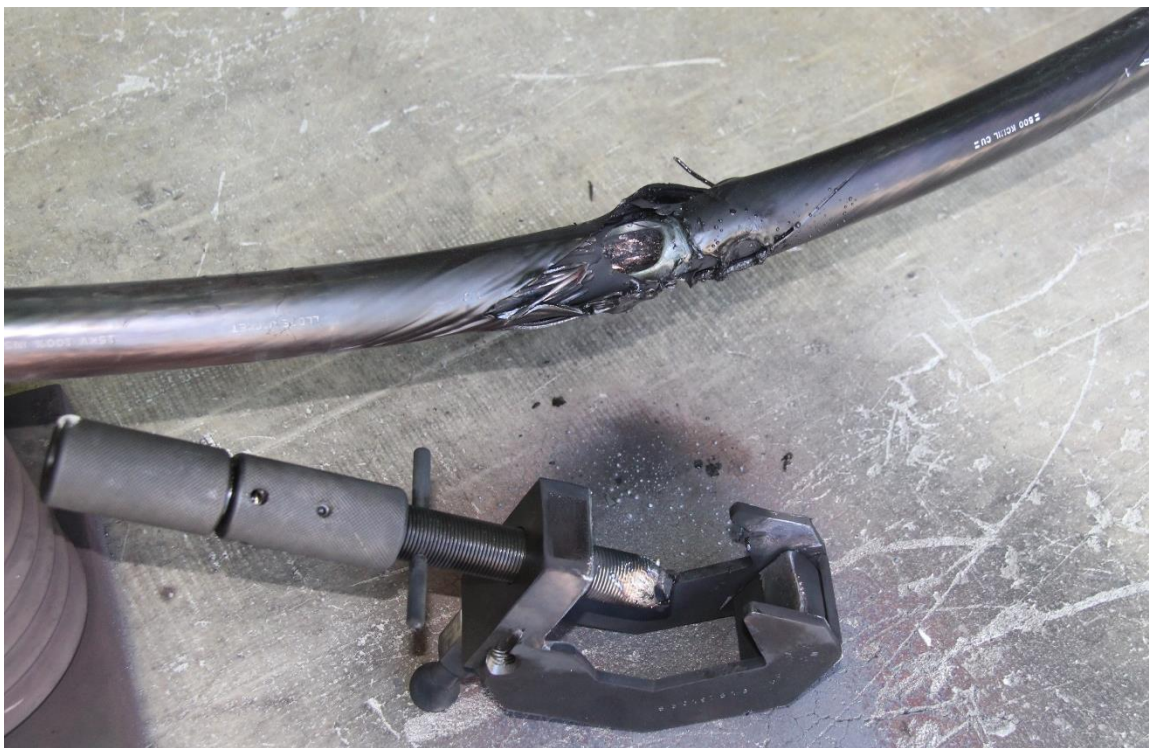
- The tool suffered damage to the barrel. The tip of the barrel is partially melted away.
- The nail did not penetrate though the cable. The nail was fused (melted) when reaching the conductor. Based on the waveform, the nail appears to fuse within  $\frac{1}{2}$  cycle. The remaining period is an arcing fault in air.
- The fault occurs upwards back toward the barrel of the tool where the nail punctured the cable. The concentric wires burn back and result in a large burn hole in the cable and thermal damage to the cable. See Figure 8-6.

**Figure 8-6: Ungrounded SPIKE tool with 13.8 kA fault, 15 cycles.**

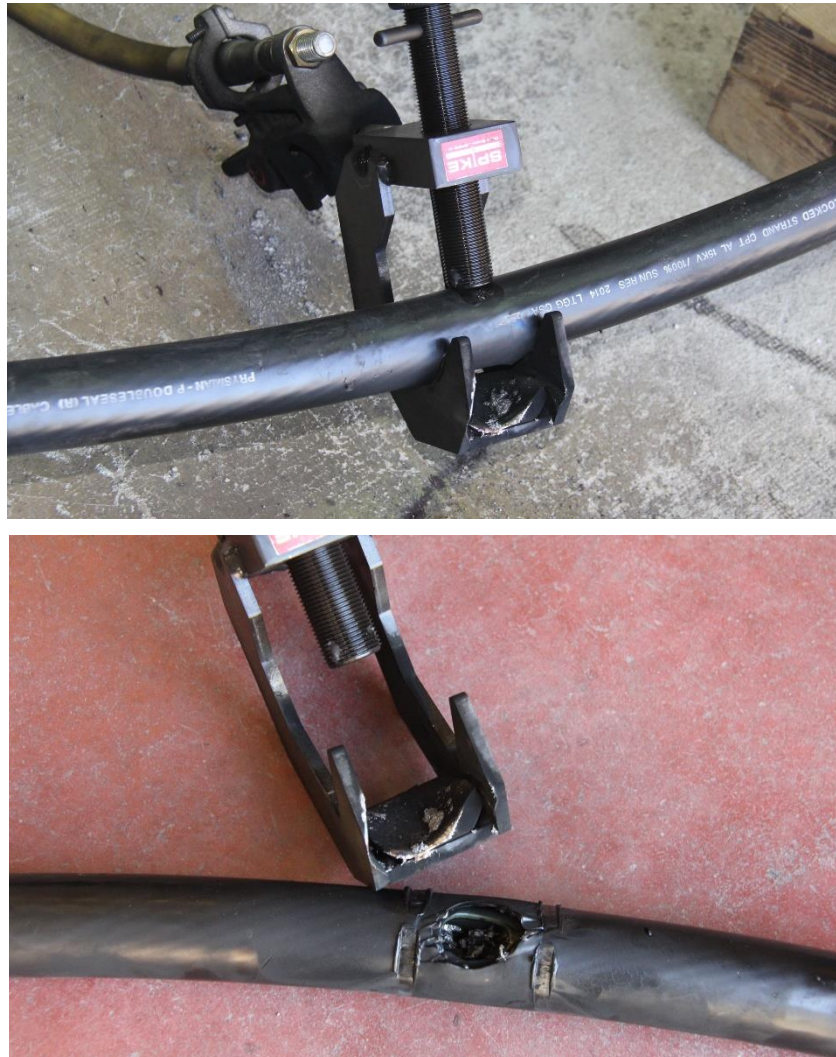
**Figure 8-8: Test 3236: Grounded SPIKE tool with ball-stud at 13.8 kA fault, 15 cycles.**

Three tests were performed with the SPIKE tool bonded to ground through the ball stud. The tool initiated the fault in all cases and withstood the fault current. There was no evidence of damage or overheating on the ball-stud and threaded connection. The tool sustained significant damage at the striker plate and “V” block. This should be expected as the tool is the arc electrode.

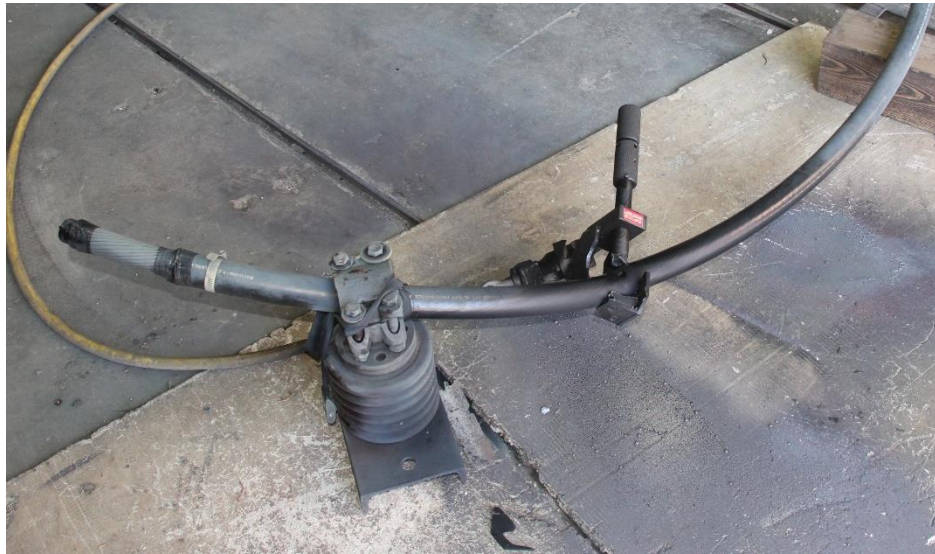
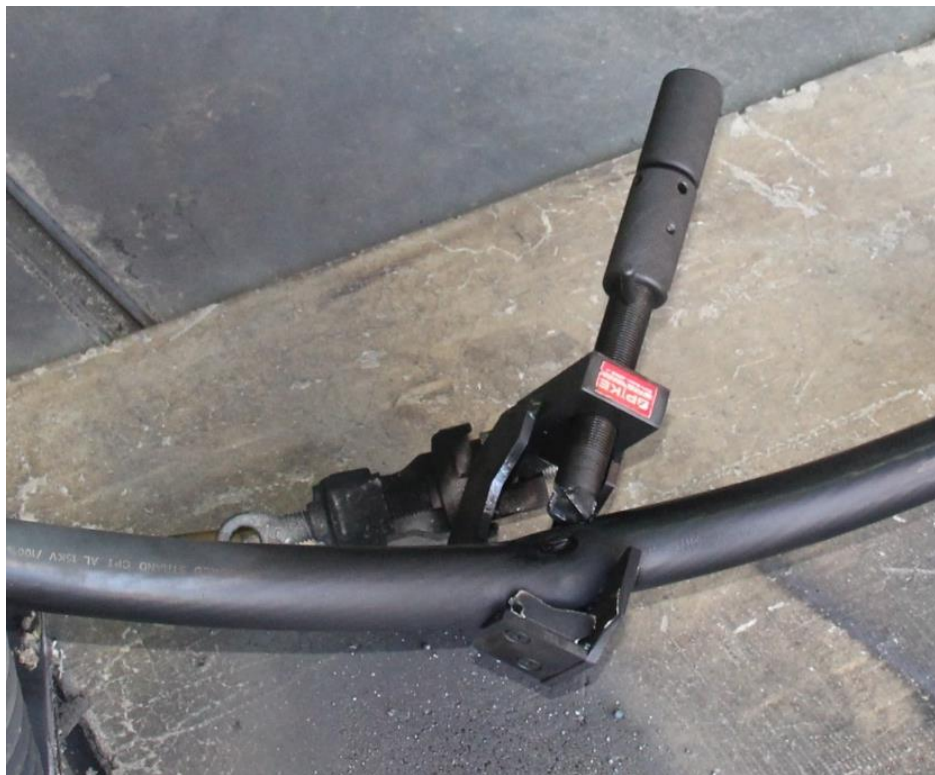
**Figure 8-9: Test 3237: Grounded SPIKE tool with ball-stud at 27 kA fault, 15 cycles.**

The use of a ball stud (20 or 25 mm) threaded into the body of the tool provides a more secure connection for higher fault currents. The tool was tested at a fault of 27 kA rms, 15 cycles. At this level the tool was severely damaged and very loose on the cable. The tool had less damage at 19 kA. It is recommended that it should not be used above a fault level of 20 kA, 15 cycles unless it's been verified that the fault clearing time is much shorter than 15 cycles.

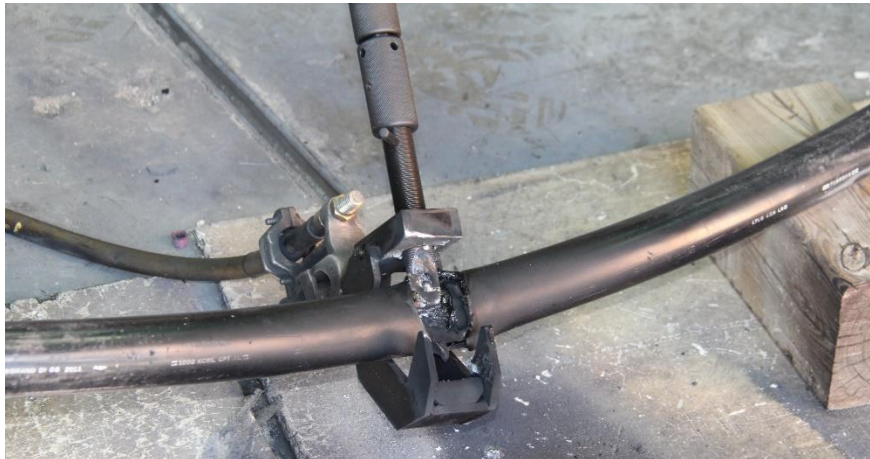
**Figure 8-10: Test 3238: Grounded SPIKE tool with ball-stud at 19 kA fault, 15 cycles.**
